Re: Former Independent Petroleum Co.
Confirmation Indoor Air Sampling

**Subject: Trip Report and Data Summary – Vapor Intrusion Sampling
Independent Petrochemical Corporation Site, Saint Louis, Missouri
CERCLA ID: MOD066919440
U.S. EPA Region 7, START 4 Contract No. EP-S7-13-06, Task Order No. 0066
Task Monitor: Michael Davis, EPA On-Scene Coordinator**

**TRIP REPORT AND DATA SUMMARY
VAPOR INTRUSION SAMPLING – MARCH 2016**

**INDEPENDENT PETROCHEMICAL CORPORATION SITE
SAINT LOUIS, MISSOURI**

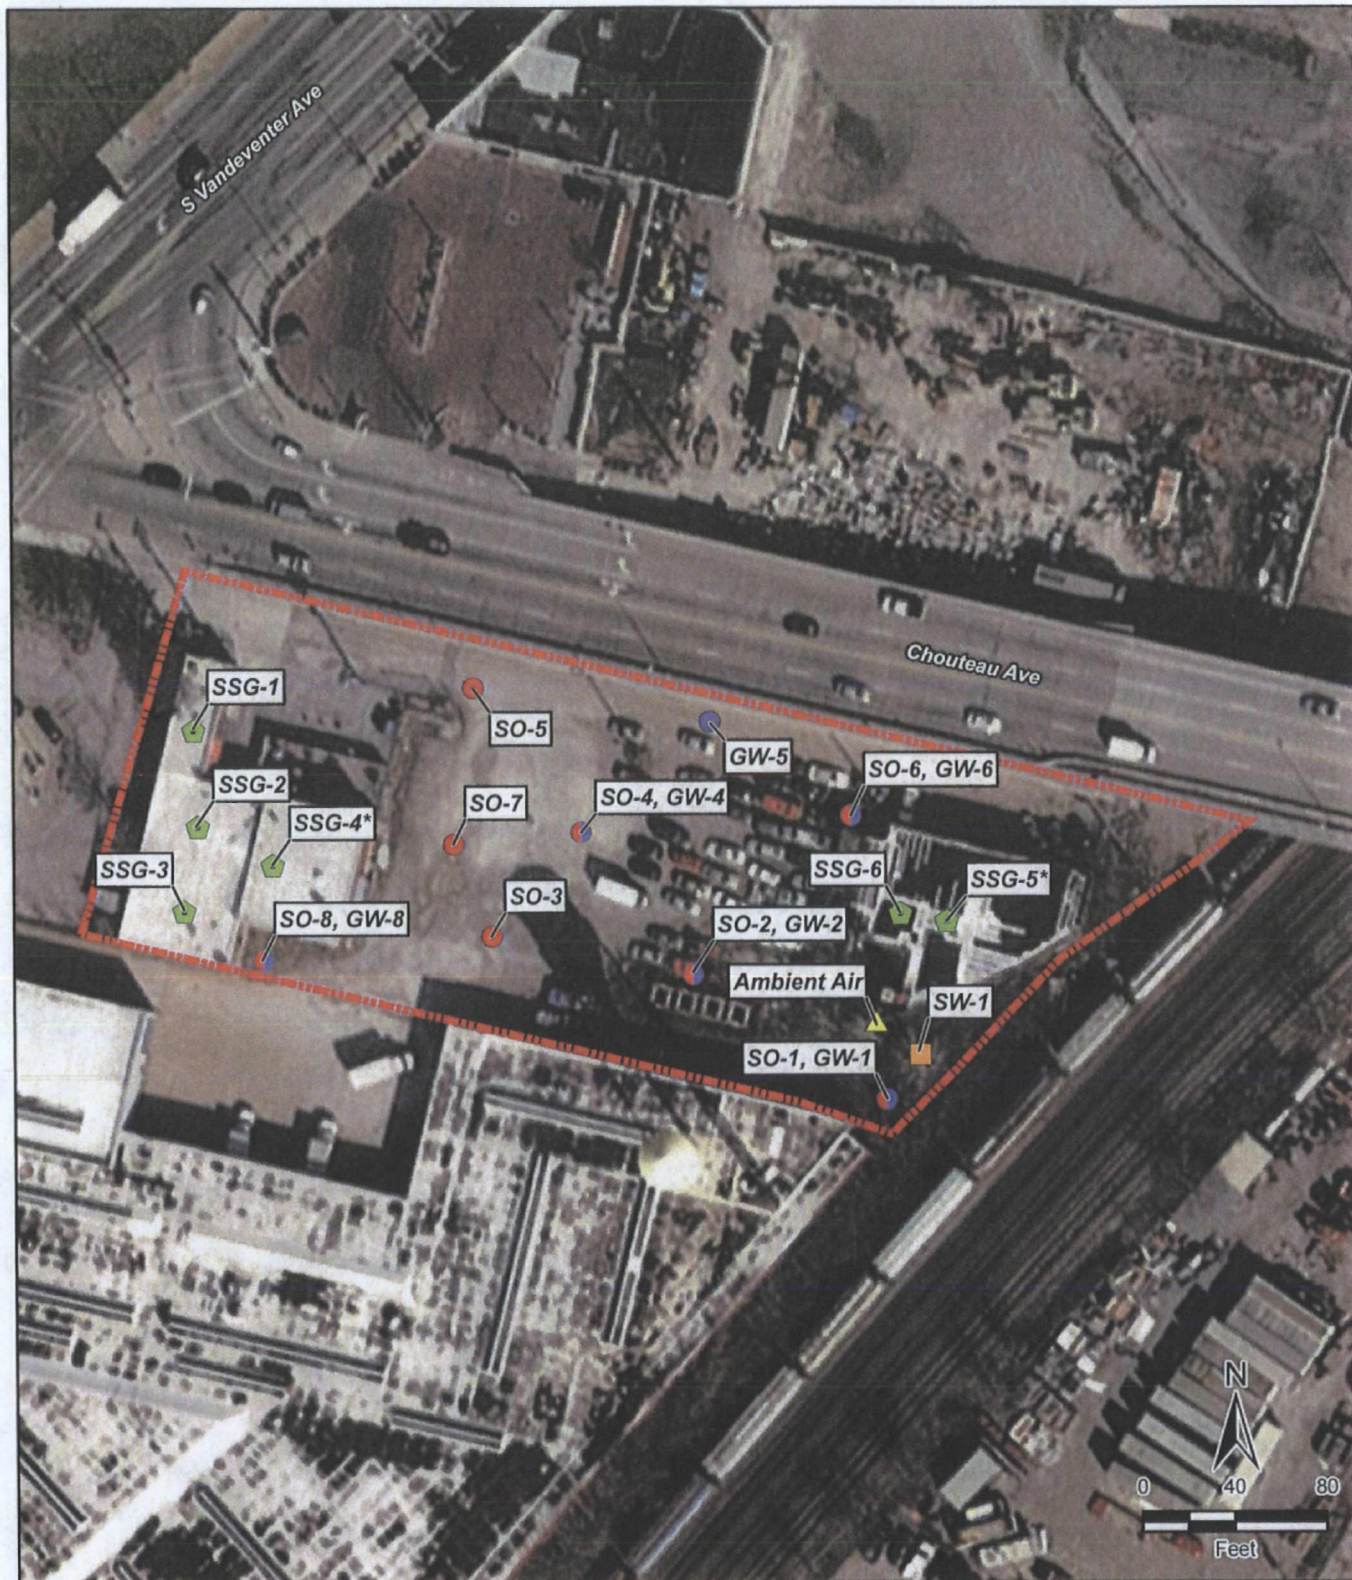
Figure 2
2014 Integrated Site Assessment
Sample Location Map

* SSG-4 and SSG-5 were co-located with indoor air sample locations during the November 2014 sampling event.

Sub-slab soil gas samples were collected from sampling ports installed at six locations at the two buildings. Four sample locations were in the bar, and two were in the warehouse. In November 2014, START conducted additional sub-slab soil gas sampling and collected an indoor air sample from each building. Figure 2 shows locations of sub-slab and indoor air sampling.

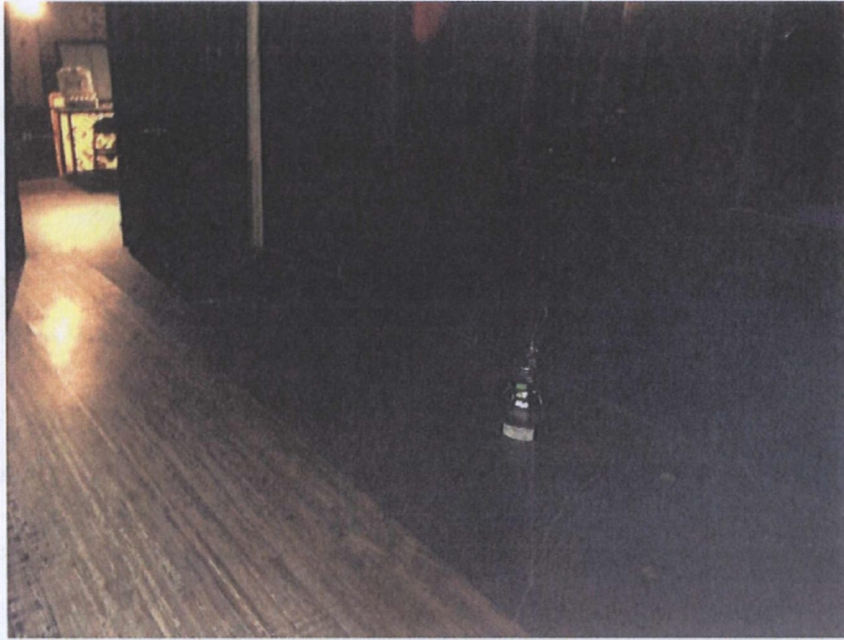
TETRA TECH PROJECT NO. X9025.14.0066.000 DIRECTION: --	DESCRIPTION	This photograph shows sample 7024-1 collection at bar dance floor near sub-slab gas port SSG-4.	1
	CLIENT	Environmental Protection Agency - Region 7	DATE 3/8/16
	PHOTOGRAPHER	Jenna Mead

Summa canisters fitted with 8-hour flow regulators were placed at the dance floor area and at the back lounge area of the bar near sub-slab ports SSG-4 and SSG-3. START and EPA returned to the site that afternoon to collect samples. All Summa sampling accorded with EPA Environmental Response Team Standard Operating Procedure (SOP) 4231.1704 – Summa Canister Sampling.

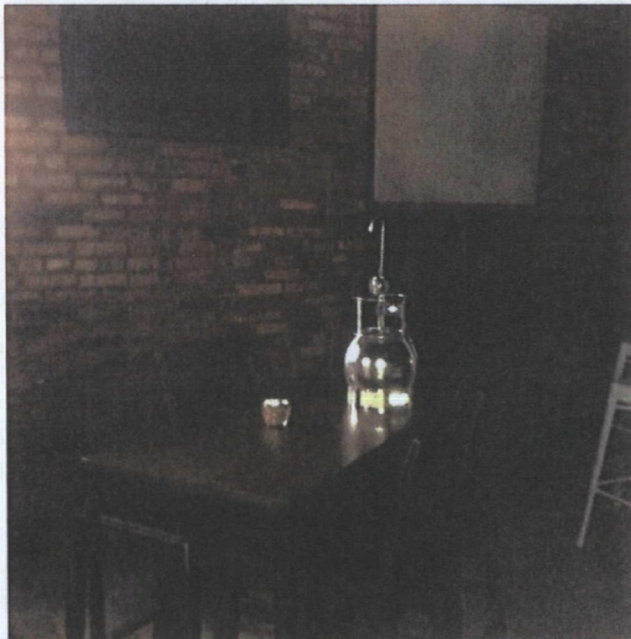
TETRA TECH PROJECT NO. X9025.14.0066.000 DIRECTION: --	DESCRIPTION	This photograph shows sample 7024-2 collection at back lounge area of the bar near sub-slab gas port SSG-3.	2
	CLIENT	Environmental Protection Agency - Region 7	3/8/16 3/8/16
	PHOTOGRAPHER	Jenna Mead

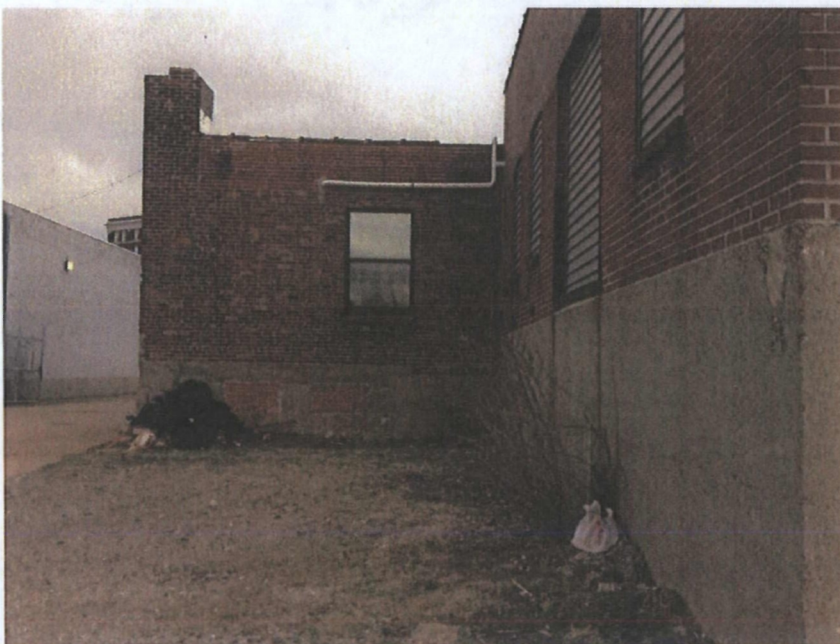
TETRA TECH PROJECT NO. X9025.14.0066.000 DIRECTION: West	DESCRIPTION	This photograph shows southern edge of bar (west building) and piping for vapor mitigation system.	3
	CLIENT	Environmental Protection Agency - Region 7	DATE
	PHOTOGRAPHER	Jenna Mead	3/8/16

Based on potential for VI at the site, the building owner installed three vapor mitigation systems at the bar (west building) in early 2016.

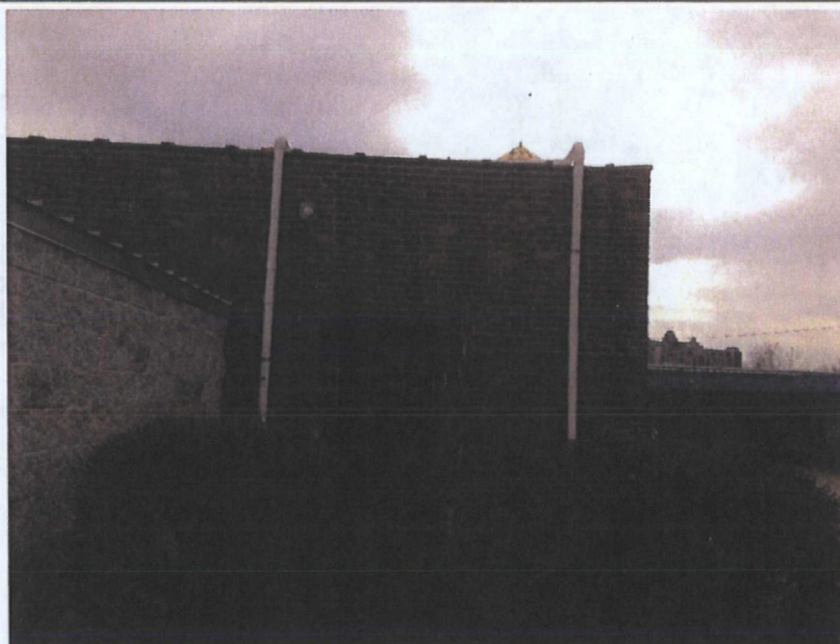
TETRA TECH PROJECT NO. X9025.14.0066.000 DIRECTION: East	DESCRIPTION	This photograph shows piping for vapor mitigation system at the west wall of the bar (west building).	4
	CLIENT	Environmental Protection Agency - Region 7	DATE
	PHOTOGRAPHER	Jenna Mead	3/8/16
